AN ENGINEERING VIEW OF THE FIRE OF MAY 4, 1988 IN THE FIRST INTERSTATE BANK BUILDING LOS ANGELES, CALIFORNIA

Harold E. Nelson

March 1989

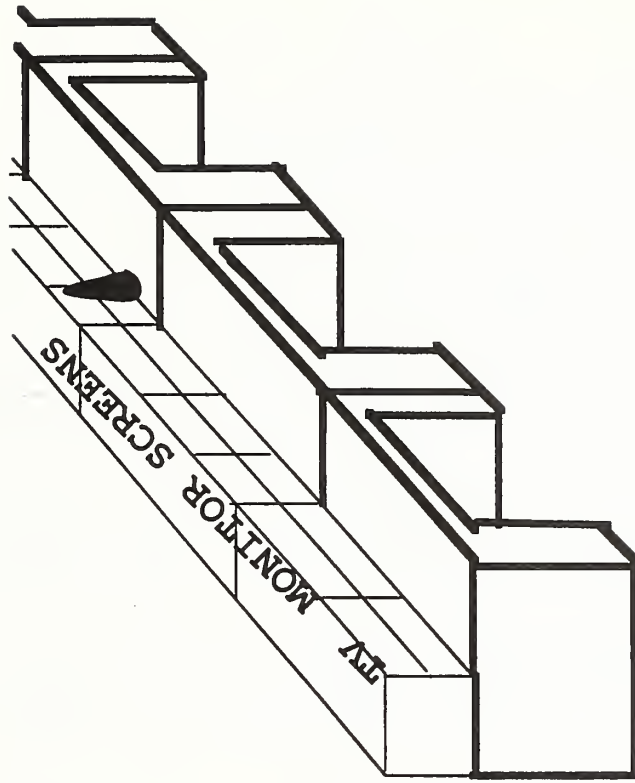
FIGURE 6. INITIAL FIRE ON A WORKSTATION

The fire trace discussed above indicates an open flaming fire of 10-20 kW approximately 3 minutes prior the 10:30 pm operation of the first smoke detector. The flame probably had a base about 6 inches in diameter and a height of about 18 inches. This is the start of analysis in this presentation. While figure 6 depicts the flame on top of the workstation it might actually have been on top of the workstation, under it, or between workstations.

12TH FLOOR ABOUT 10:25 - 10:27 A SMALL FLAME (<20KW) EXISTS INVOLVING SOME PART OF A WORKSTATION

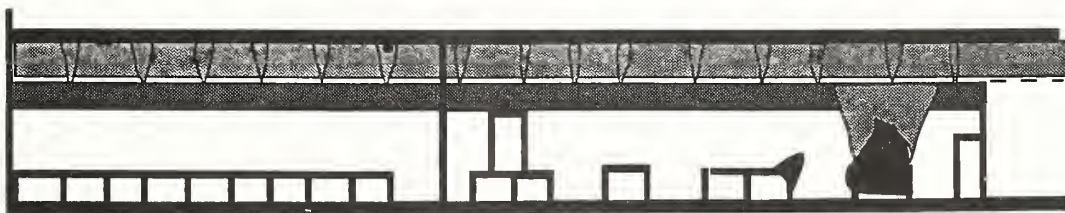
FIGURE 14. CONDITIONS AT 10:33 P.M.

**12TH FLOOR 10:33 - 1000KW - SMOKE <2 FT THICK - 200F - ZONE 2 -
PLENUM DETECTOR RESPONDS**

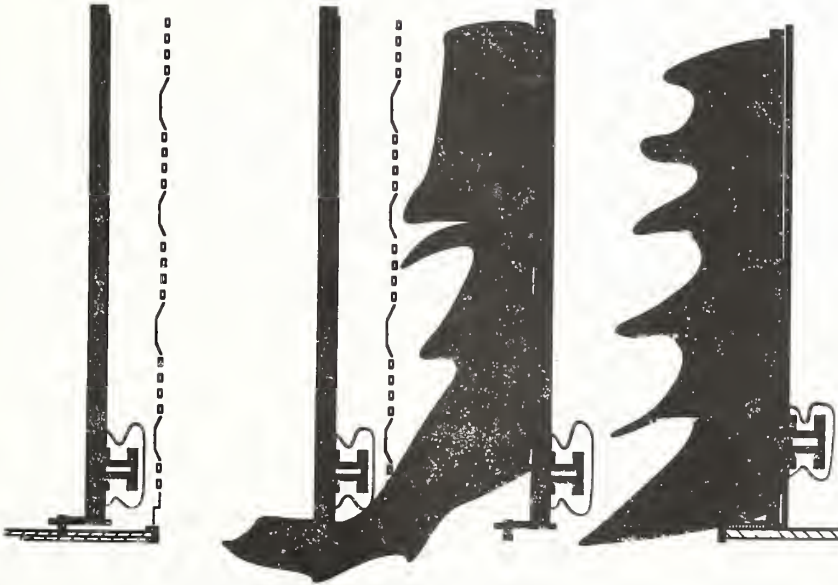
FIGURE 27. SPREAD TO 14TH FLOOR

It is reported that the fire spreads to the 14th floor at about 11:40 p.m. As shown in figure 27, the means of extension is similar to the spread to the 13th floor. It is believed that by this time the involved floors may be reacting to each other resulting in raising the neutral plane on the 12th floor and lowering it on the 13th. If so there was a modest enhancement of the flame extension on the 13th floor. This is depicted by the difference in the shape of the flames shown in figure 27.

ABOUT 11:40 PM IGNITION ESTABLISHED ON
14TH FLOOR
